AN EVALUATION ON THE HYDROGEOMORPHOLOGICAL PROPERTIES OF THE EŞEN STREAM BASIN¹

ABSTRACT

Keywords: Eşen Stream, Basin, Hydrogeomorphological, Landslide, Flood.

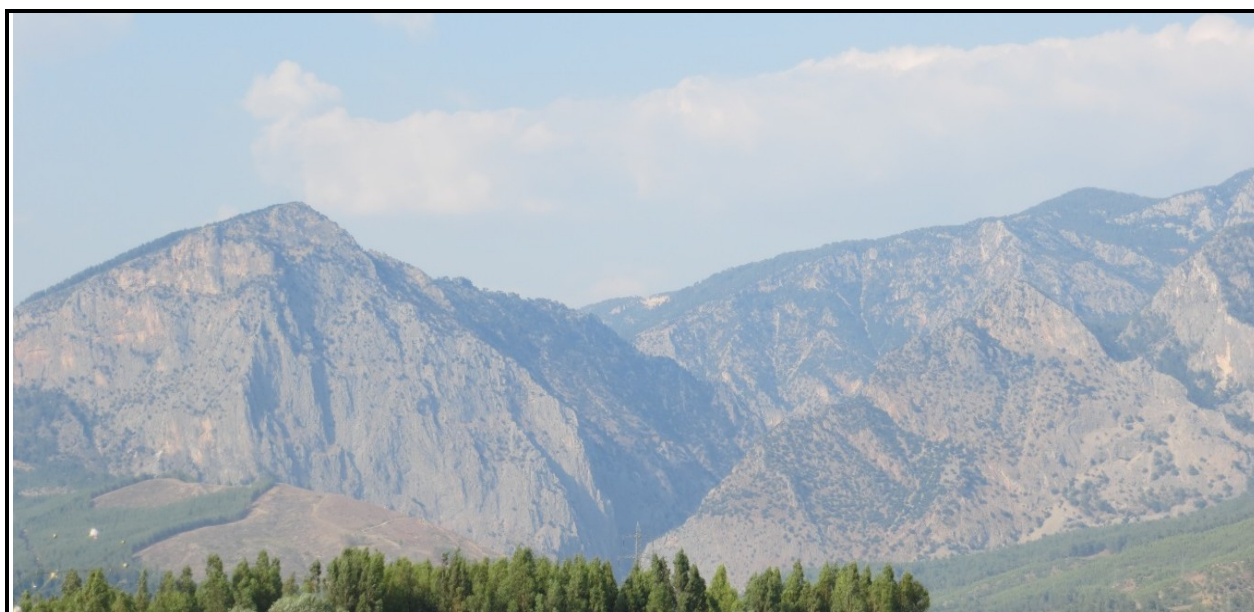
Photograph 1. Ören Fault; is Surfacing the South Side of the Güneydağı (1046 m) a Fault which is in Facta NW-SE Direction Dip-Slip Normal Fault.

The basin, has also been broken up by the fault lines at the same time (Photograph 1). There are subsidiary fault lines beside the main fault lines which have the north-south as the general direction. These lines which show a gradual feature, support the idea that the Eşen Stream Valley corresponds to a graben. At the bottom of the valley, especially at the fields where the bed enlargens the braided dike is present. Yet two large canyon valleys have formed at the fault line's front fields.

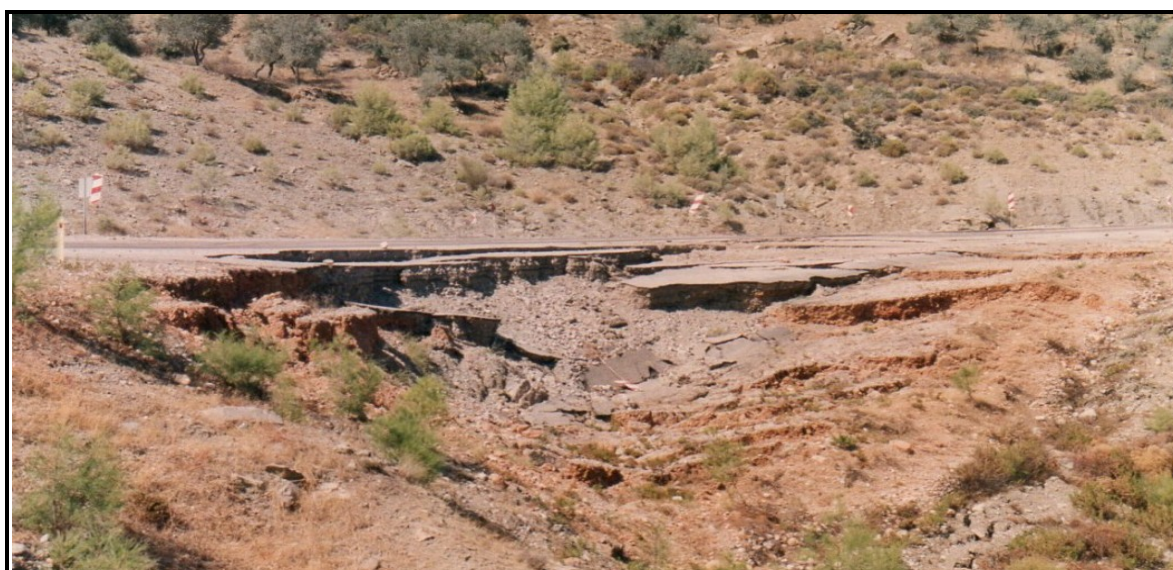
Photograph 2. Damaged Highway of the Landsliding Region in Kemer-Antalya Highway's 5.th Kilometer

2.2. Landslides: The landsliding fields within the Eşen Stream Basin are common in the sections where the slope is more when passed from the high mountainous fields to the plain and valley bottoms. They are not very common. Because the factors causing the landslide are present at particular points of the basin. As a result, a large proportion of the landslides which occurred until today, has been determined to have formed in the fields made for place gaining from the forest and in the road cuts. The flysch series situated on the mesozoic limestones of the road cut in the 8. kilometer of the Kemer-Ceylan road, have been observed to slide to the west from time to time. Also the Eocene flysch series deformed in terms of balance in the 5 and 10. kilometers of the highway between Kemer and Antalya, slide through the Kincılar Stream from the main rock and hinder the highway traffic from time to time (Photograph 2-3). In a field section in the Kirsecik quarter of Bayırköy at the 12. Kilometer of the Kemer-Antalya highway, no life has been lost during the landslide of 1978-1979 winter, some houses have been damaged.

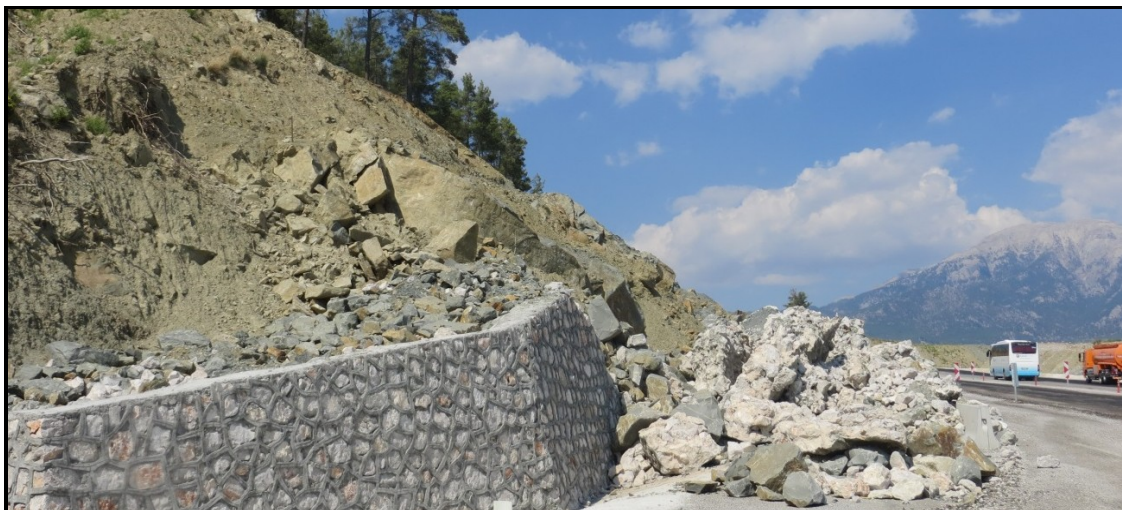
Photograph 3. The Landslide Forming at the 10.th Kilometer of Kemer-Antalya Highway from Time to Time Hinders the Highway Traffic.

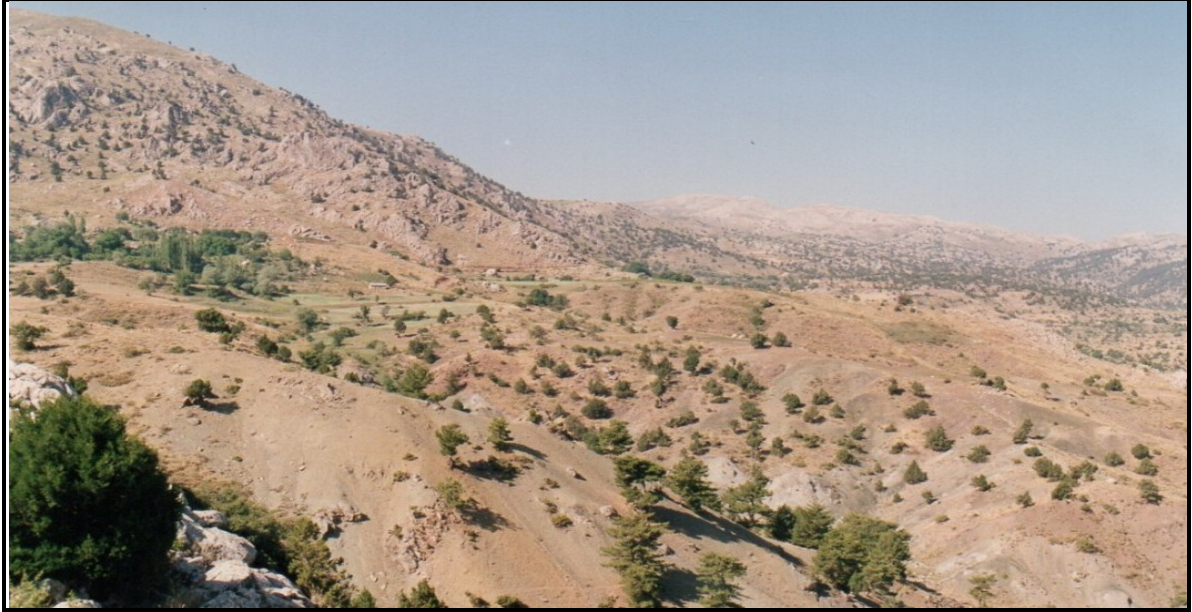
Photograph 4. The Northern Slopes of Eren Hill (2677 m) are under Landslide Threat.

The northern slopes of Eren T. immediately rising at the southern part of the Seki Basin (2677 m) are crumbled with gradual faults. In the field where the ophiolites are at the bottom and the discordant limestone beds are at the top; Temelköy, Ceylanköy have the topography that will be exposed to landslides at any moment (Map 3). There are evidence that the landslide is still continuing in the field (Photograph 4).

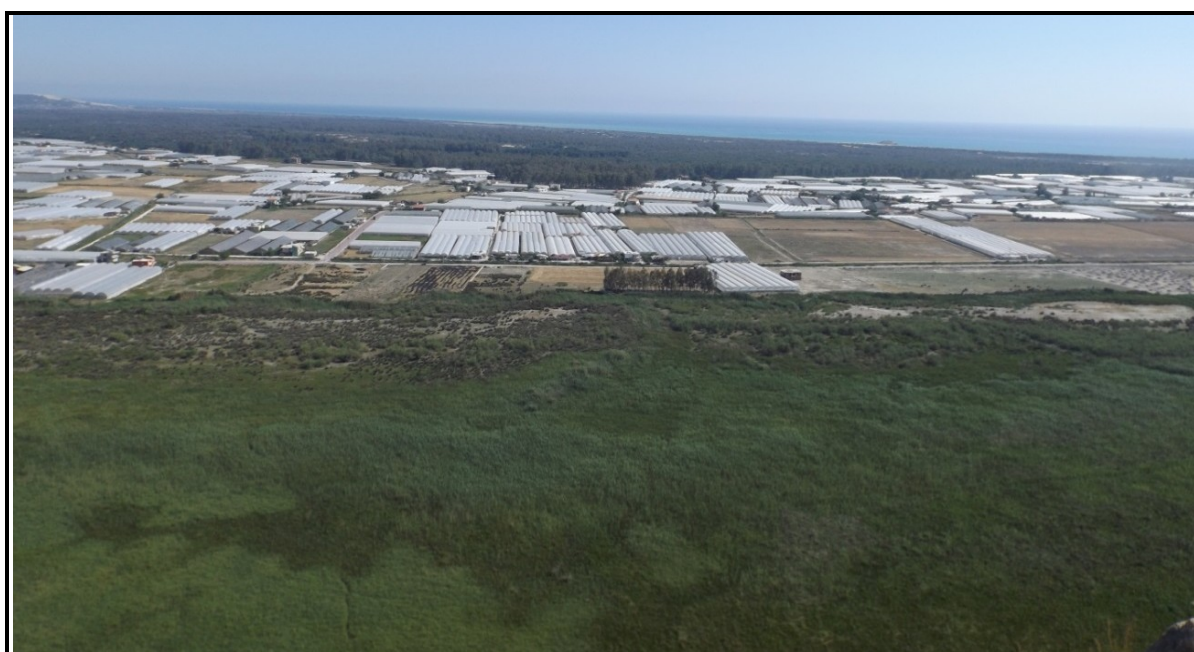
Photograph 6. Marsh Fields on the Ada Position of Delta in the Eşen Stream

2.3.6. *Delta Plain*: Eşen Stream, enters into the delta plain after the Kınık Pass and flows in the north south direction showing a braided draining. The stream that is included in a meandering bed near Kerimler district later on, reaches the sea from Çayağzı district. In order to prevent damages during floods, floodgates were made on both sides of Eşen Stream until the Kerimler quarter of town of Kınık, in the south of Kumluova. Despite these floodgates which have partially prevented from floods, the water spreads from the stream bed, which is flattened in floods, and formed a 20-25 km² flowage plain. In areas where the groundwater level is very close to the surface, after floodwaters the swamps and ponds have formed. In particular, there are marshes which are caused by floods in the vicinity of Kerim and Ada (Photograph 6).

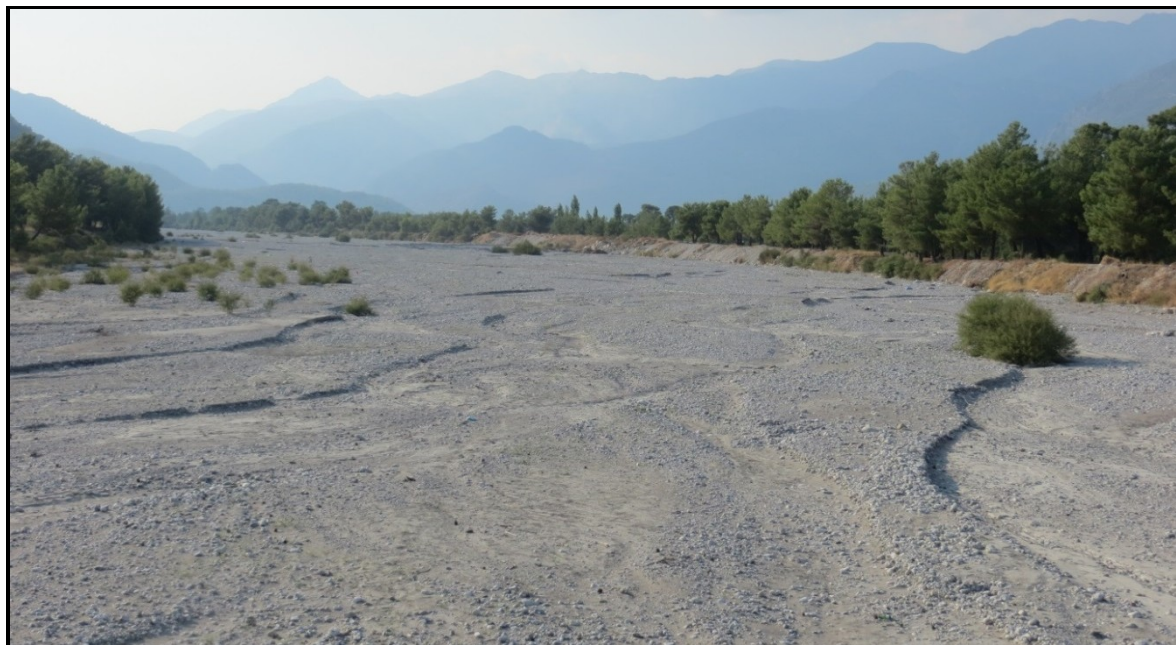
Photograph 7. View of Akçay (Deliçay) Stream Bed Having Lost Its Water in Summer Season

2.4. Slantings: In the field of examination, in the period between November and March the streams are relatively high as a result of the more frequent heavy rains, when the rain is seen more, they become thinner during the hot and dry summer. There is no water in Akçay (Photograph 7) and in Tezli Stream in summer except for the Eşen Stream, Seki Stream and Karaçay. The lowest flow values are seen in August in the Eşen Stream and Seki Stream. The long during average flow in the Eşen Stream in that month has been 22.7 m³/seconds. The period where the thin version of the main streams having the constant flow in the examination field starts from the June month's beginning until the end of November, corresponds to an arid period (Table 2).

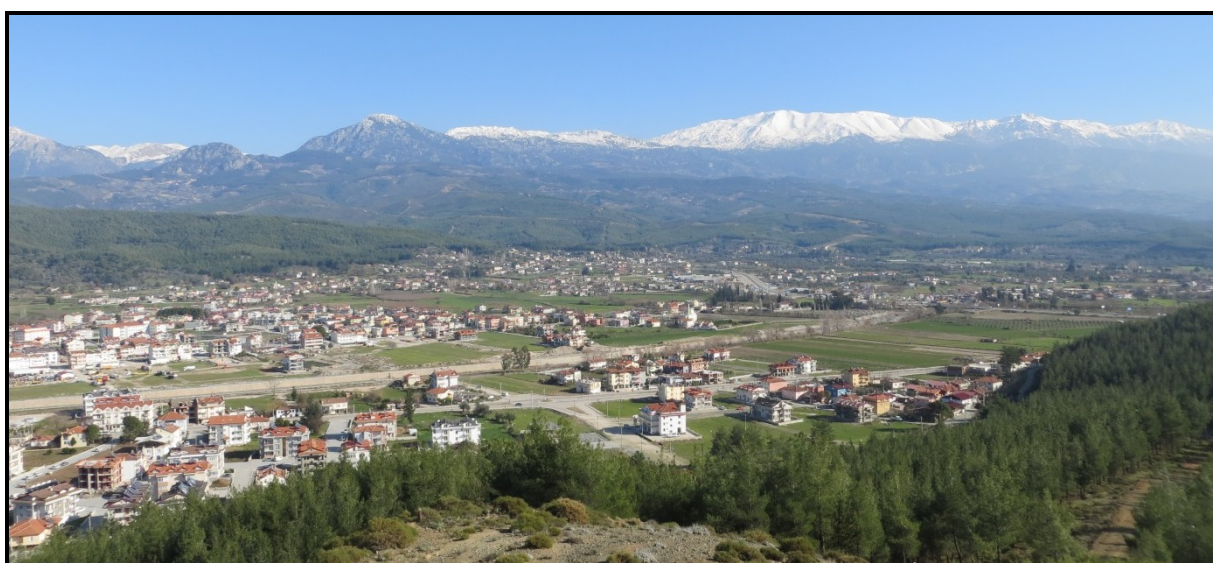
Photograph 8. The Eşen Stream Graben which is Extending in the North-South Direction.

The presence of trenches and young faults in the basin and the presence of some ancient cities under water and alluvium show the influence of young tectonic movements. The N-S, NE-SW direction (Photograph 8) on the Eşen Stream Graben extending in the north-south direction produced a large number of sloping normal faults (Map 3).

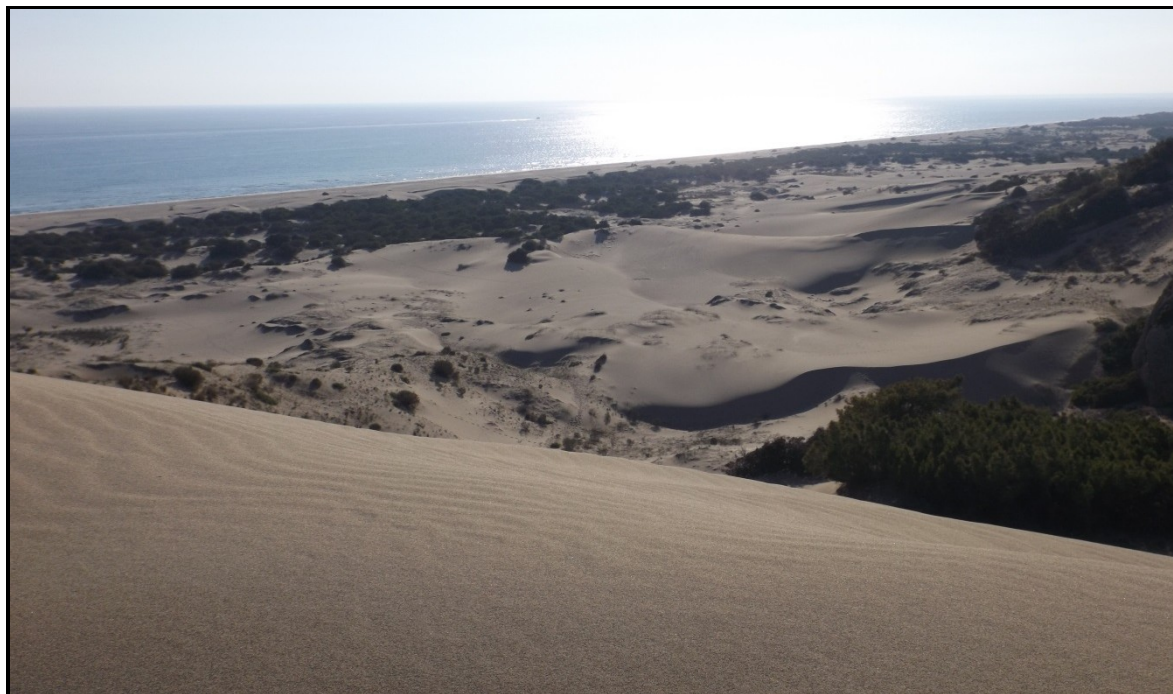
Photograph 9. Coastal Dunes in the Eşen Stream Delta Plain

2.6. Moving Dunes: There are sand dunes along the coast of the Eşen Stream Delta Plain, which is located in the study area (Photograph 9). It lies 12 km from the Zeytin Cape in the west to İnceburun in the east. The moving sand dunes are 4 km within the west of the delta area (Map 3).

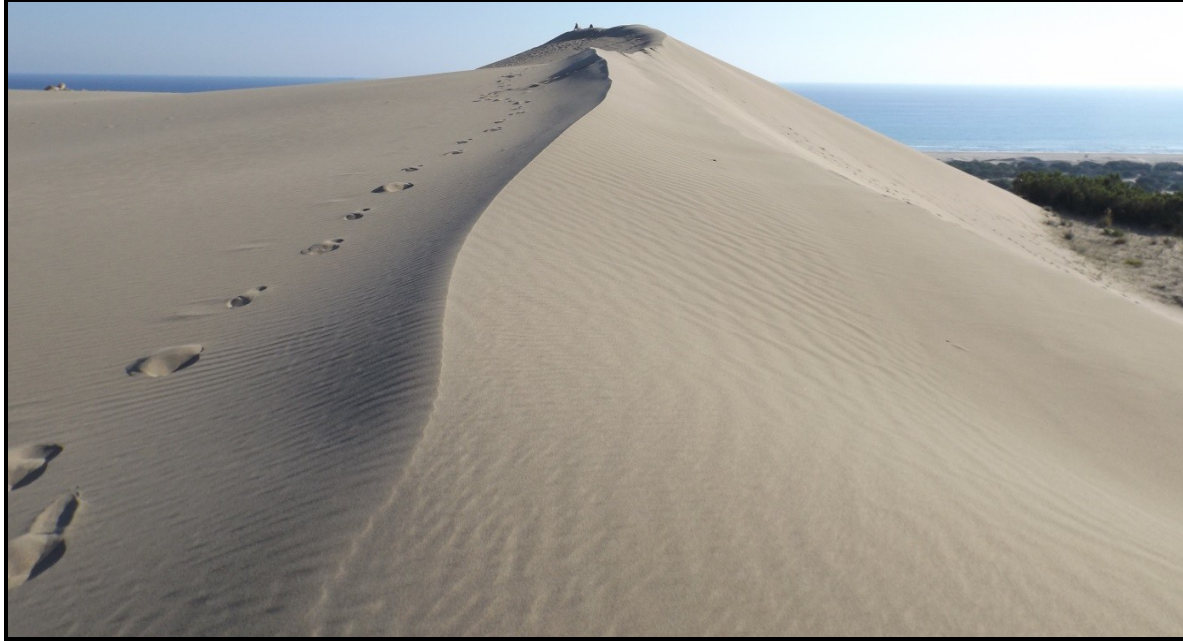
Photograph 10. An Appearance of the Dune Hills in the Eşen Stream Delta

The sand, silt and clay sized material brought to the sea by the Eşen Stream, which is the source of the sand that forms the sand dune field was formed as a result of the accumulation by the waves and scattered on both sides of the delta front (Photograph 10). From time to time, the lagoons and set lakes have formed as a result of the shifting of the moving dunes and lagoon. Efforts to prevent sand dune erosion, initiated by the Ministry of Forestry in 1961, have yielded successful results. The fact that the coastal dunes take off by the influence of the southern sector winds and reach up to the hills 5 km inside the coast, the part of the ancient city of Patara covered with coastal sand dunes and the removal of them from the sea by sand dunes are evidences showing what the effects of sand dunes might be. The cutting of the eucalyptus forest by the neighborhood people, today which was formed as a result of the afforestation activities may cause the sand dunes to move again. Measures must be taken for preventing that.

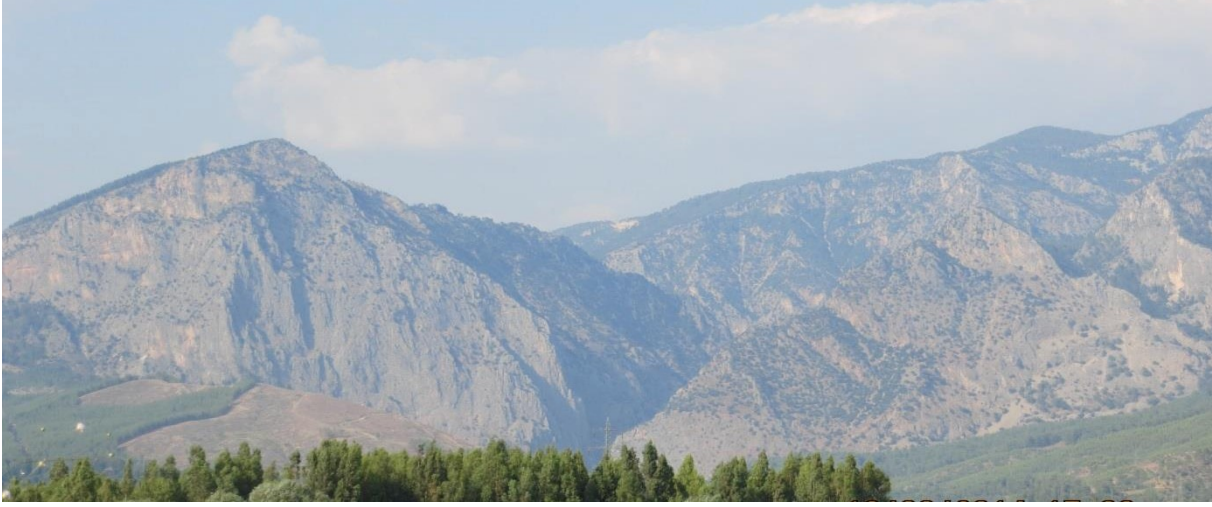
Fotoğraf 1. Ören Fayı; Güneydağı'nın(1046 m) Güney Kenarında Yüzeyleyen Fay NW-SE Doğrultulu Eğim Atımlı Normal Faydır.

Havza, aynı zamanda faylarla da parçalanmış bulunmaktadır(Fotoğraf 1). Genel doğrultuları kuzey-güney olan ana fayların yanında tali faylar da yer almaktadır. Basamaklı bir özellik gösteren bu faylar, Eşen Çayı Vadisi'nin bir grabene tekabül ettiği fikrini kuvvetlendirmektedir. Vadi tabanında, özellikle yatağın genişlediği sahalarda örgülü mecrâ görülmektedir. Ancak fay hattına cephe sahalarda iki büyük kanyon vadi meydana gelmiştir.

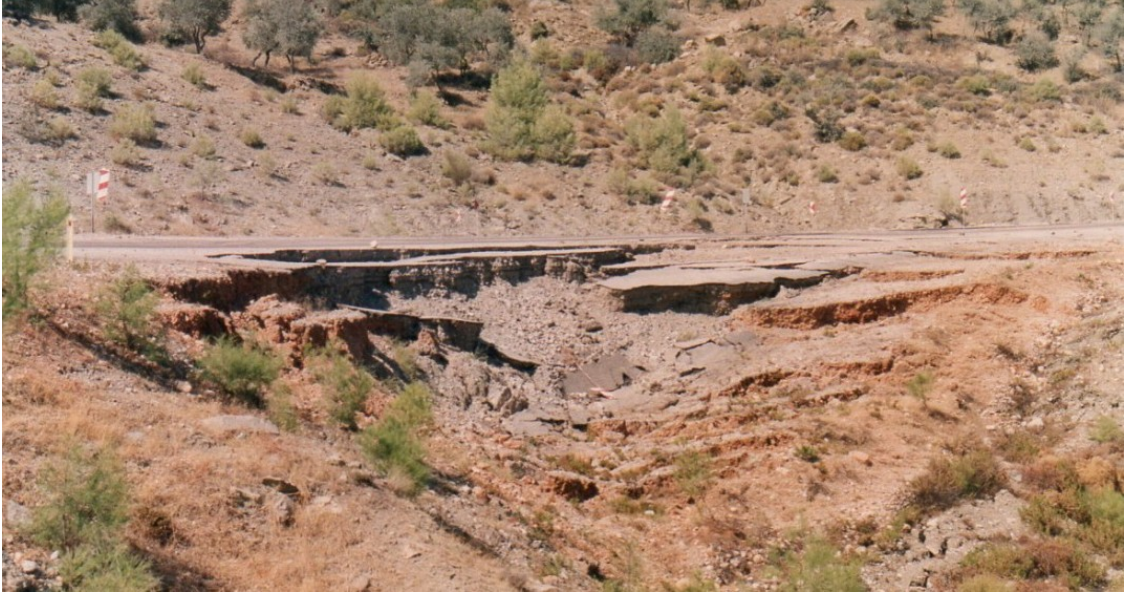
Fotoğraf 2. Kemer-Antalya Karayolunun 5. Kilometresindeki Heyelanlı Bölgede Tahrip Olmuş Karayolu

2.2. Heyelanlar: Eşen Çayı Havzası'nda heyelanlı sahalara, yüksek dağlık sahalardan ova ve vadi tabanlarına geçildiğinde eğimin fazla olduğu kesimlerde rastlanmaktadır. Bunlar pek yaygın değildir. Çünkü heyelanlara sebep olan faktörler havzanın muayyen yerlerinde bulunmaktadır. Nitekim bugüne kadar vuku bulmuş heyelanların büyük bir kısmı ormandan yer kazanmak üzere açılmış sahalardan ile yol yarmalarında meydana geldiği tespit edilmiştir. Kemer-Ceylan yolunun 8. kilometresindeki yol yarmasında Mesozoik kalkerler üzerinde yer alan flişli serinin yer yer batıya doğru kaydığı gözlenmiştir. Ayrıca Kemer'i Antalya'ya bağlayan karayolunun 5 ve 10. kilometrelerinde denge açısı bozulan Eosen fliş serileri ana kayadan doğudaki Kıncılar Deresi'ne doğru kaymakta ve zaman zaman karayolu trafiğini aksatmaktadır(Fotoğraf 2-3). Kemer-Antalya karayolunun 12. kilometresindeki Bayırköy'e bağlı Kirsecik mahallesindeki bir bölüm arazide, 1978-79 kışında meydana gelen heyelânda can kaybı olmamakla beraber, bazı evlerin hasar gördüğü tespit edilmiştir.

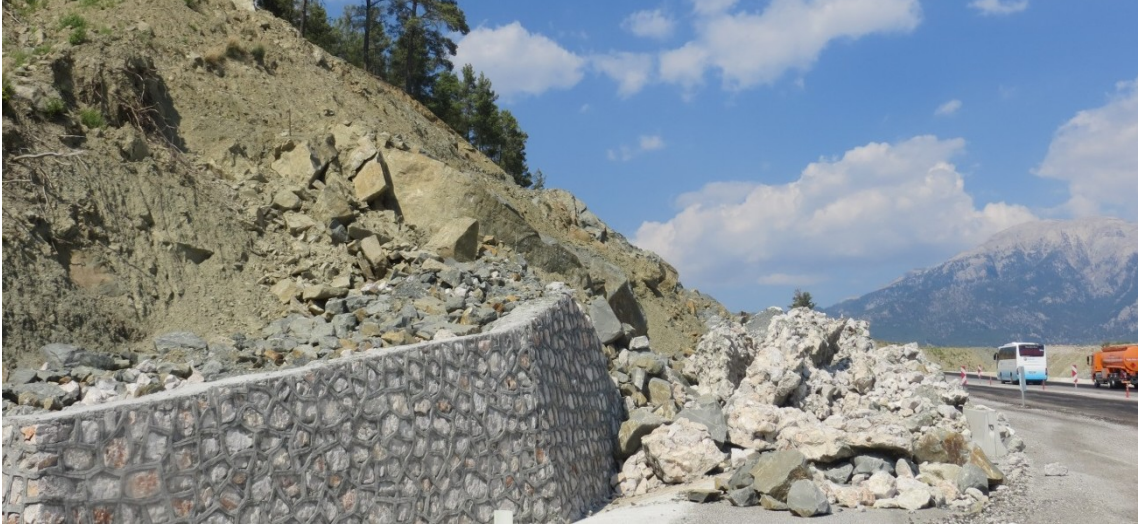
Fotoğraf 3. Kemer-Antalya Karayolunun 10. Kilometresinde Zaman Zaman Meydana Gelen Heyelan Sonucu Karayolu Trafiđi Aksamaktadır.

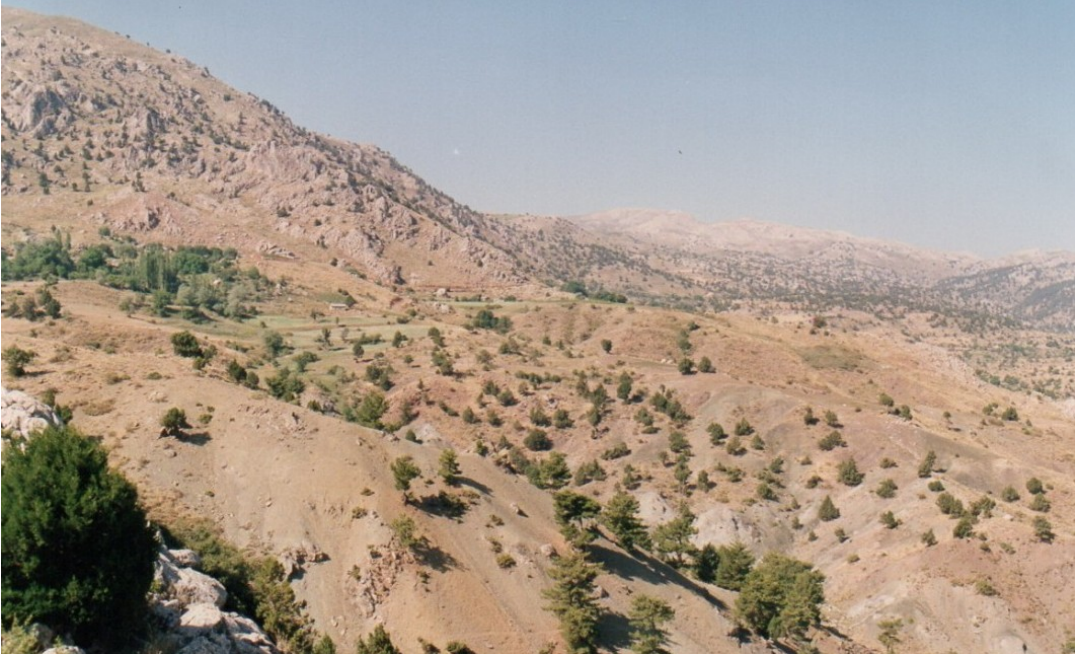
Fotoğraf 4. Eren Tepe'nin (2677 m) Kuzey Yamaçları Heyelan Tehdidi Altında Bulunmaktadır.

Seki Havzası'nın güneyinde birdenbire yükselen Eren T. nin (2677 m) kuzey yamaçları kademeli faylarla parçalanmıştır. Altta ofiolitler, üstte ise diskordant olarak kalker tabakaların yer aldığı sahada; Temelköy, Ceylanköy her an heyelana maruz kalacak topoğrafyadadır (Harita 2). Arazide heyelânın halen devam ettiđini gösteren delillere rastlanmaktadır(Fotoğraf 4).

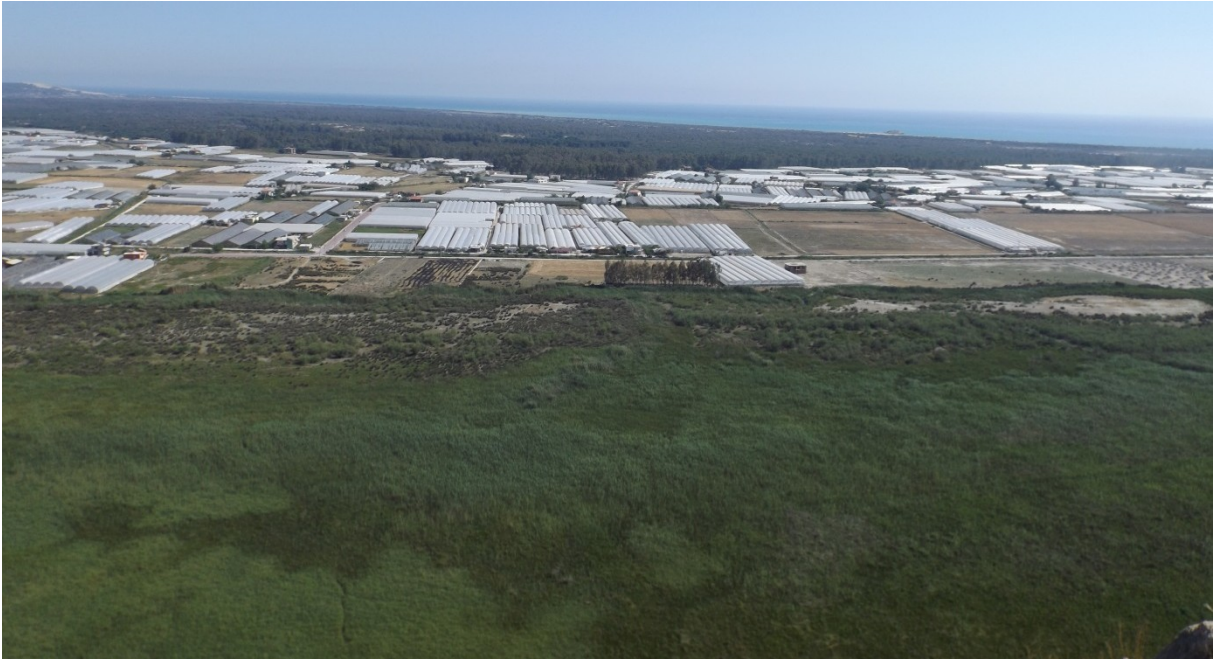
Fotoğraf 6. Eşen Çayı Deltasındaki Ada Mevkiindeki Bataklık Sahalar

2.3.6.Delta Ovası: Eşen Çayı, Kınık Boğazı'ndan sonra delta ovasına girmekte ve örgülü drenaj özelliği göstererek kuzeyden güneye doğru akmaktadır. Daha sonra Kerimler mahallesi yakınlarında menderesli bir yatağa dahil olan akarsu, Çayağzı mevkiinden denize ulaşmaktadır. Taşkın esnasındaki zararları önlemek amacıyla Kınık kasabası ile Kumluova güneyindeki Kerimler mahallesine kadar Eşen Çayı'nın her iki kenarında seddeler yapılmıştır. Kısmen taşkınların önlendiği bu seddelere rağmen, taşkınlarda basık şekilde olan akarsu yatağından sular çevreye yayılmakta ve 20-25 km² lik bir feyezana ovası teşekkül ettirmiştir. Yeraltı su seviyesinin oldukça yüzeye yakın olduğu kesimlerde taşkına müteakip bataklık ve göllenme meydana gelmektedir. Özellikle Kerimler ve Ada mevkilerinde taşkınların yol açtığı bataklıklar görülmektedir (Fotoğraf 6).

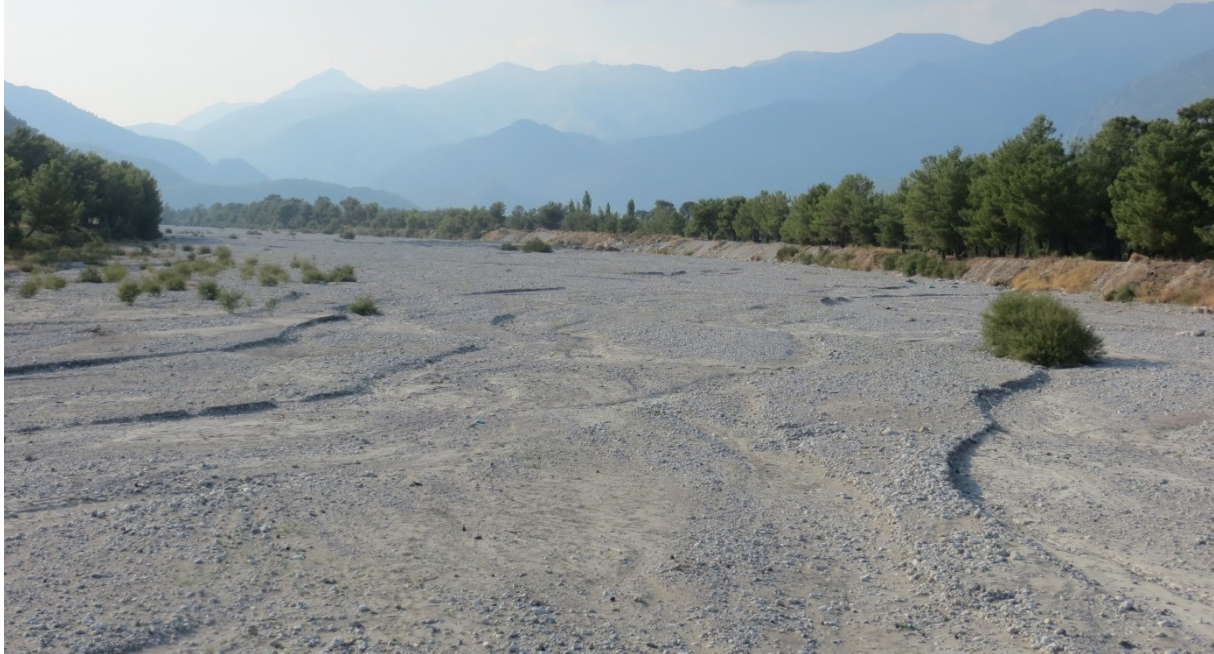
Fotoğraf 7. Yaz Mevsiminde Sularını Kaybeden Akçay(Deliçay) Dere Yatağından Görünüm

2.4. Çekikler: İnceleme sahasında, yağışların nispeten yüksek olduğu ve sağanak yağışlarında fazla görüldüğü Kasım-Mart arasındaki devrede taşkınlarla sebep olan akarsular, sıcak ve kurak geçen yaz mevsiminde cılızlaşırlar. Eşen Çayı, Seki Çayı ve Karaçay dışındaki Akçay (Fotoğraf 7) ve Tezli Deresi'nde yaz aylarında su bulunmaz. Eşen Çayı ve Seki Çayı'nda en düşük akım değerlerine Ağustos ayında rastlanır. Eşen Çayı'nın bu aydaki uzun süreli ortalama akımı $22.71 \text{ m}^3/\text{sn}$ 'dir. İnceleme sahasının sürekli akışa sahip ana akarsularında çekik halinin görüldüğü devre Haziran ayı başlarından Kasım ayı sonuna kadar olup, kurak bir döneme tekabül etmektedir.

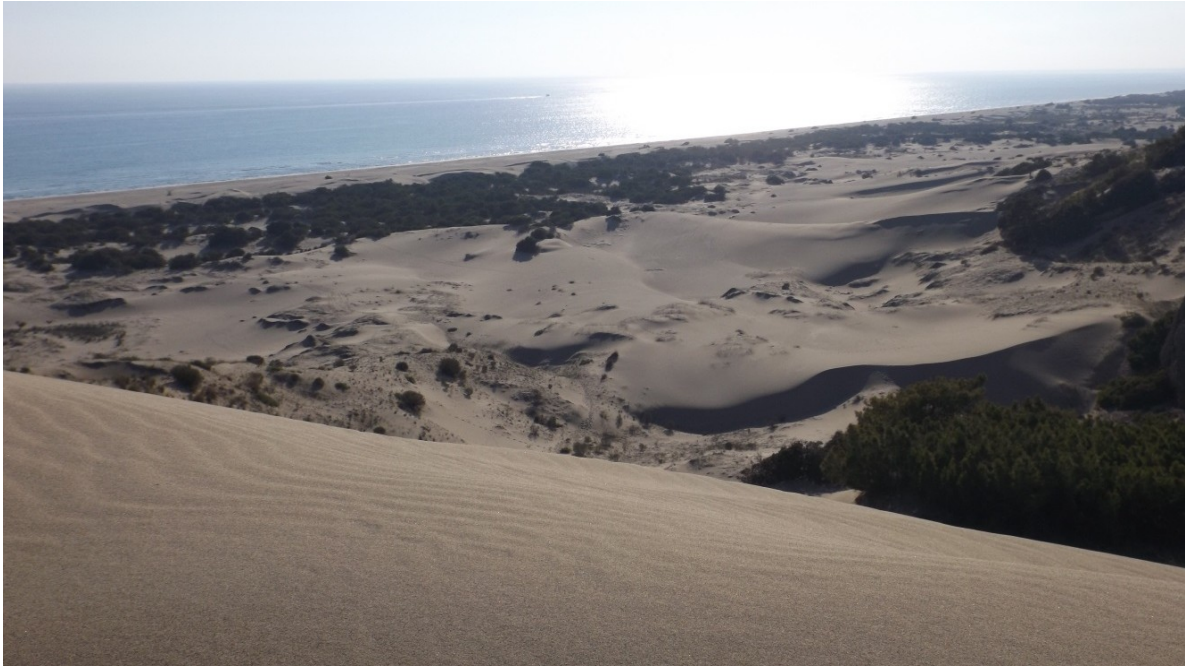
Fotoğraf 9. Eşen Çayı Delta Ovası'ndaki Kıyı Kumulları

2.6. Hareketli Kumullar: Etüt sahasında yer alan Eşen Çayı Delta Ovası'nın kıyısı boyunca kumullar yer alır (Fotoğraf 9). Batıda Zeytin Burnu'ndan, doğudaki İnceburun'a kadar uzanan 12 km'lik mesafede bulunur. Hareketli kumullar, delta sahasının batı yakasında 4 km. kadar içeriye sokulmuşlardır (Harita 2).

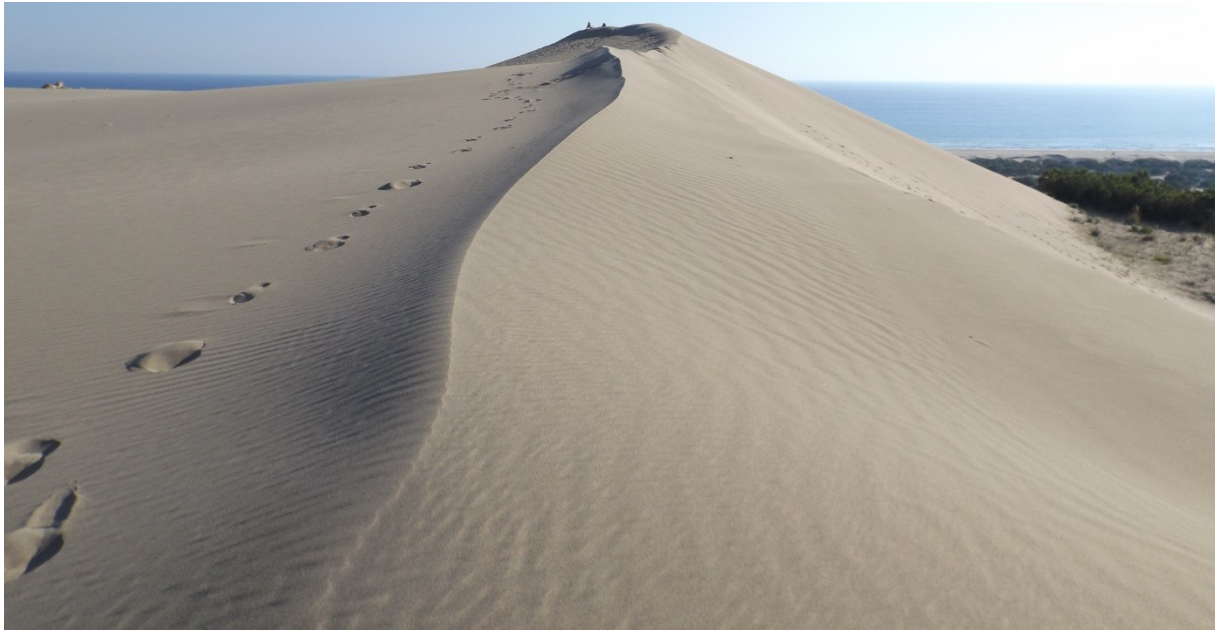
Fotoğraf 10. Eşen Çayı Deltası'ndaki Kumul Tepelerinden Görünüm

Kumul sahasını meydana getiren kumların kaynağı Eşen Çayı'nın getirdiği kum, silt ve kil boyutundaki malzemenin denize bırakılması, daha sonrada dalgalarla da delta cephesinin her iki tarafına doğru dağıtılarak biriktirilmesi sonucunda teşekkül etmiştir(Fotoğraf 10). Zaman zaman hareketli olan kumulların yer değiştirmesi ile oluşmuş lagon ve set gölcükleri meydana gelmiştir. Orman Bakanlığı tarafından 1961 yılında başlayan kumul erozyonunu önleme çalışmaları başarılı sonuçlar vermiştir. Kıyı kumullarının güney sektörlü rüzgârların etkisiyle havalanarak kıyıda 5 km içerdeki tepelere kadar ulaşması, Patara antik kentinin kıyı kumullarıyla kısmen örtülerek buradaki koyun kumullarla denizden koparılması, kumulların etkilerinin neler olabileceğini gösteren delillerdir. Bugün ağaçlandırma çalışmaları sonucunda teşekkül etmiş okaliptüs ormanının çevre halkı tarafından kesilmesi, kumulları tekrar harekete geçirebilir. Bunun için gerekli önlemlerin alınması gerekmektedir.
